## **“Full” Reserve Study**

## **The Glen of Pacific Grove**

**Pacific Grove, CA**

**Report #: 7492-0**

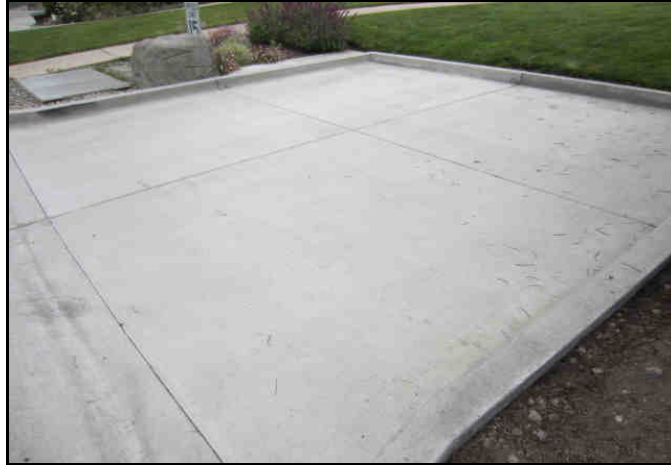
**Comp #: 103 Concrete Surfaces - Repair**

Evaluation: According to the BOD, trip hazards are handled as an operating expense. This component provides funding to repair the concrete driveways. The cost estimate below was provided by the client.

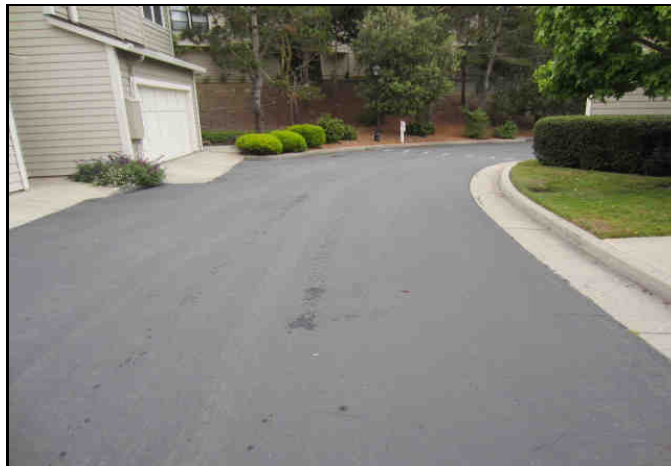
Evaluation: The asphalt is scheduled for removal and replacement in the 2012/13 fiscal year. Assume good conditions once the project is complete. The cost estimate below was provided by the client.

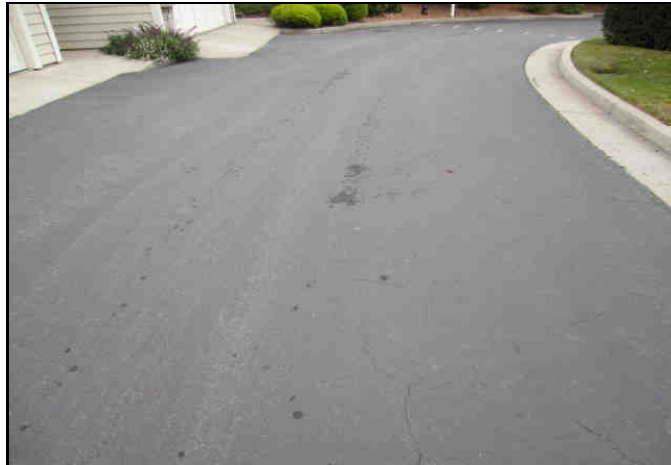
**Comp #: 202 Asphalt - Seal/Repair**

Evaluation: Asphalt is scheduled to be replaced in the 2012/13 fiscal year. New asphalt should be seal coated approximately 12- 18 months after installation, we assume the cost to seal the new asphalt is included in the replacement bid. This component provides funding for future sealing.

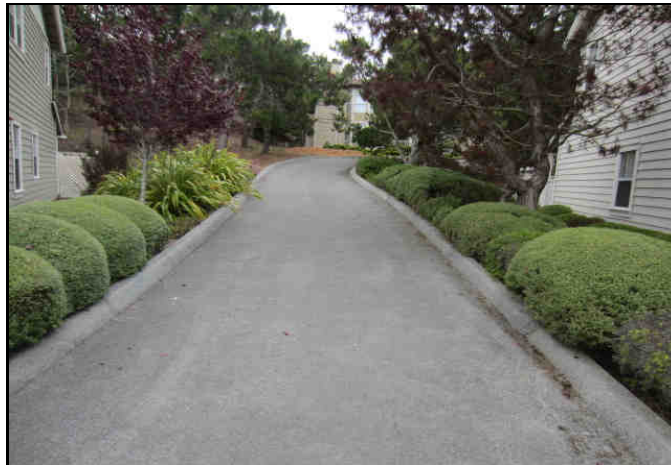
**Comp #: 203 Asphalt Path - Resurface/Repair**

Evaluation: There is an asphalt path that connects to the neighboring Association. The HOA is responsible for approximately 50% of the pathway. Handle repairs as an operating expense when needed. No Reserve funding necessary at this time.

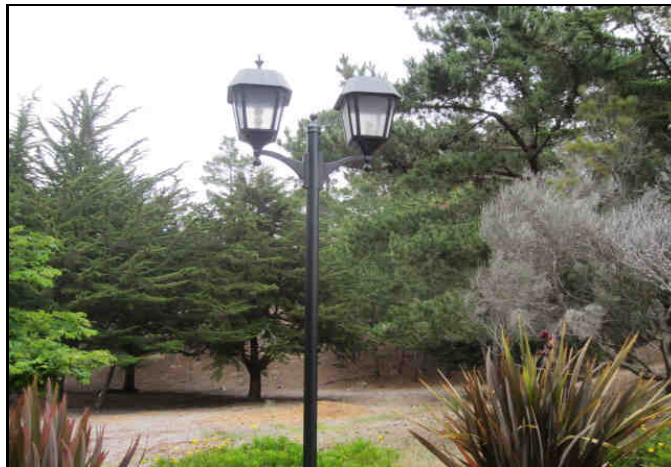
**Comp #: 320 Pole Lights - Replace**

Evaluation: These are reportedly the original fixtures, but they are well maintained and are aging well at this time. The fixtures receive frequent painting and are well protected against major rusting. Continue to paint to maintain a positive appearance, we anticipate replacement in the interval outlined below.

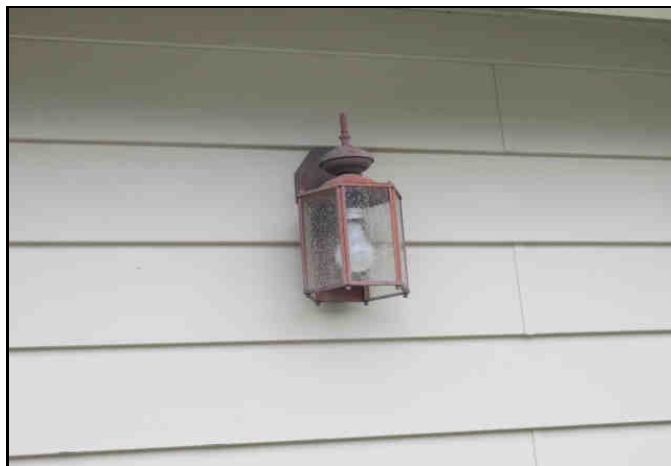
**Comp #: 324 Wall Lights - Replace**

Evaluation: We were unable to test the fixtures at the time of the site inspection. We assume the fixtures are operating properly at this time. Fixtures are well attached to the building exteriors at this time. We anticipate replacement in the interval outlined below.

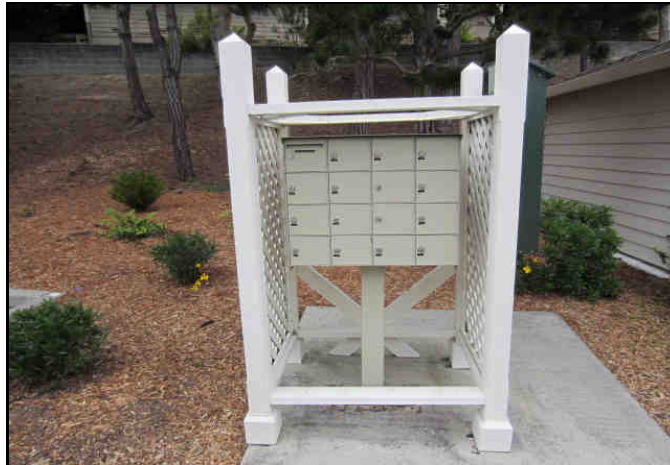
**Comp #: 403 Mailboxes - Replace**

Evaluation: Mailboxes have a slightly dated appearance, but are intact and aging well at this time. No indications of damage or abuse noted at this time. We recommend periodic cleaning and painting to protect against rust. This component provides funding for replacement in the interval outlined below.

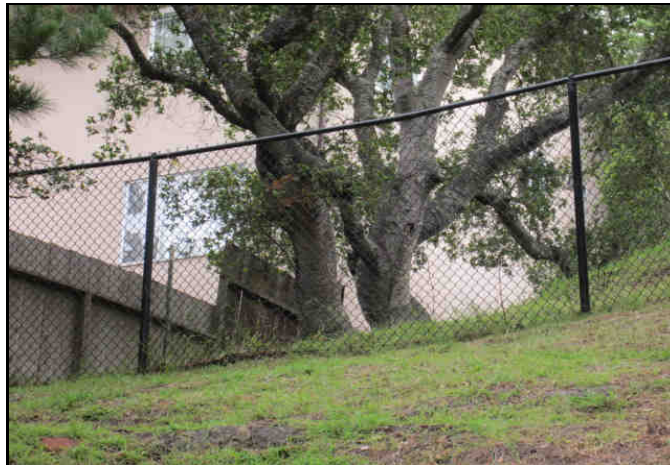
**Comp #: 502 Chain Link Fence - Replace**

Evaluation: Replacement of the tennis court fencing is not a huge priority of the Association. The perimeter fencing conditions vary by location. There are some areas that are leaning and will likely require repairs. This component provides funding to replace all chain link fencing as outlined below.

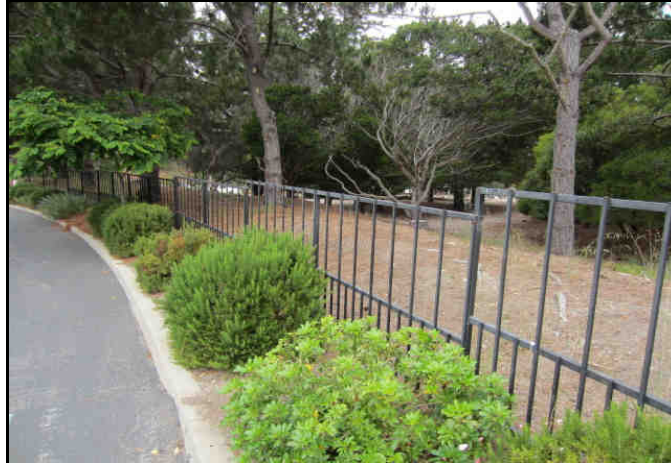
**Comp #: 503 Metal Fence - Replace**

Evaluation: All of the metal fencing has been replaced as of the start of the 2012/13 fiscal year. Fencing is new and in good condition at this time. We recommend periodic painting to maximize the useful life of the metal.

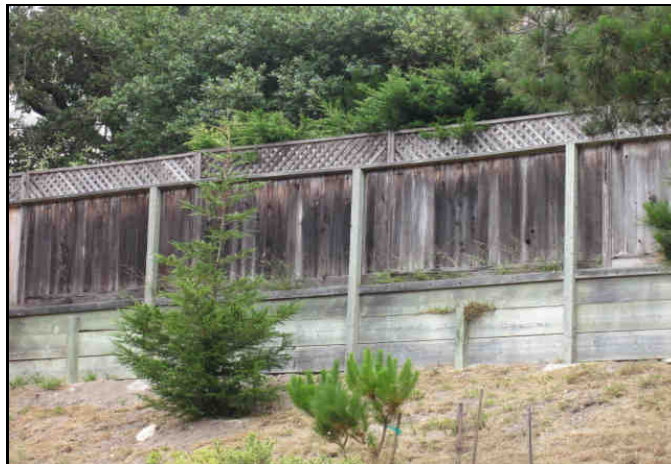
**Comp #: 505 Wood Fence - Partial Replace**

Evaluation: Conditions vary by location. No expectation to replace all areas at one time. This component provides funding for partial replacement in the interval outlined below.

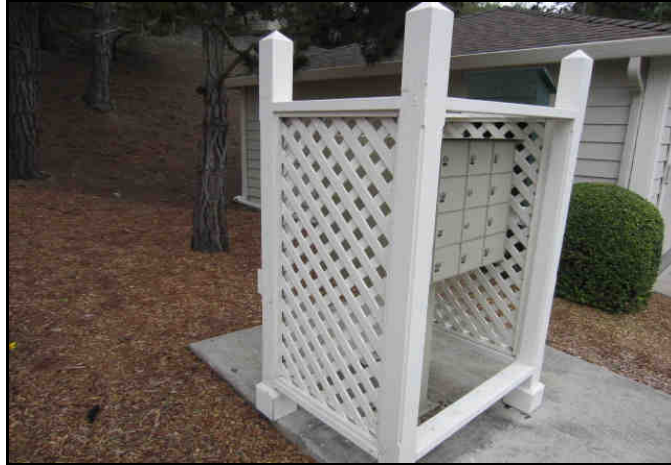
**Comp #: 506 Lattice Fence - Repair**

Evaluation: According to the Board, the Association is handling repairs as an operating expense. No Reserve funding necessary at this time.

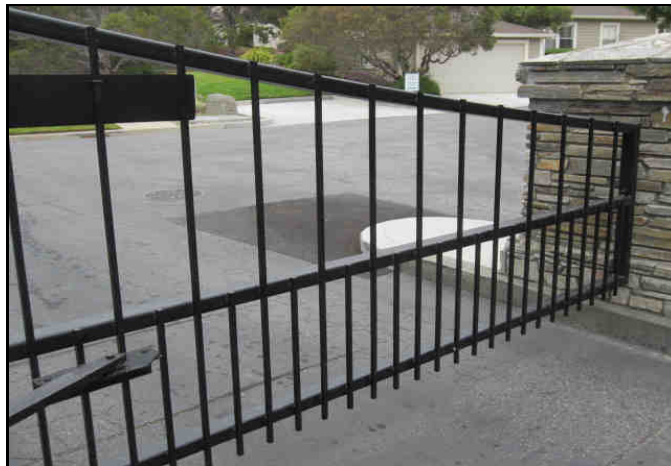
**Comp #: 702 Vehicle Gates - Replace**

Evaluation: The metal vehicle gates are well attached to the newly replaced pillars. The gates receive regular painting and appear to be aging well at this time. We anticipate replacement in the interval outlined below.

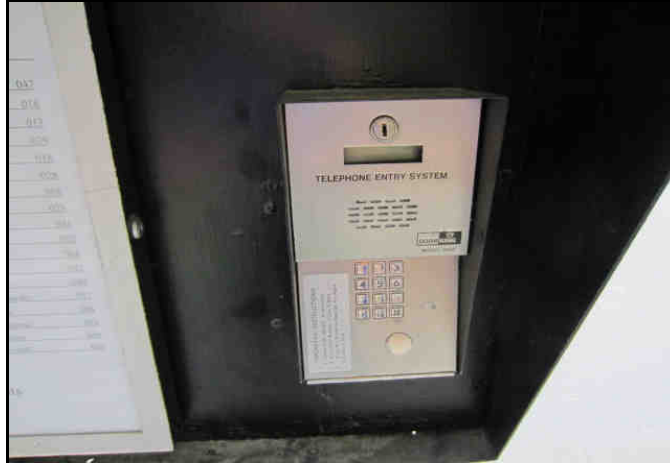
**Comp #: 704 Intercom - Replace**

Evaluation: (1) Doorking model # 1802. The unit is nearing the end of its estimated useful life and will likely require replacement in the next couple years.
