Update “No Site-Visit” Reserve Study

The Glen of Pacific Grove HOA Pacific Grove, CA

Report #: 7492-2
For Period Beginning: January 1, 2015
Expires: December 31, 2015
Date Prepared: August 28, 2014

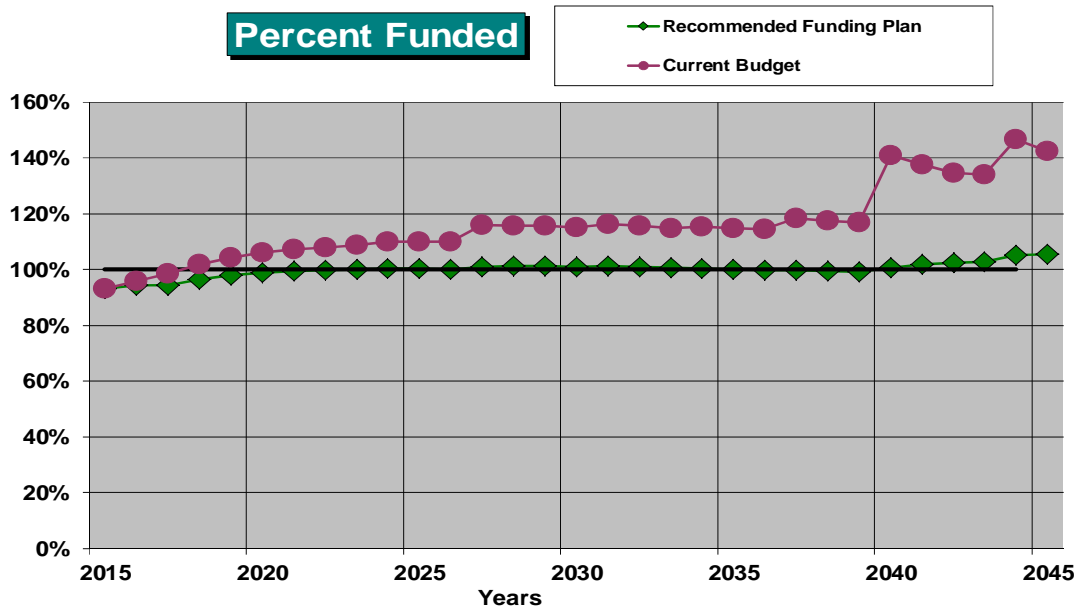
Figure 4

This figure shows this same information, plotted on a [Percent Funded](#) scale.
