Update “With-Site-Visit” Reserve Study

The Glen of Pacific Grove HOA Pacific Grove, CA

Report #: 7492-3
For Period Beginning: January 1, 2016
Ending: December 31, 2016

Date Prepared: September 8, 2015

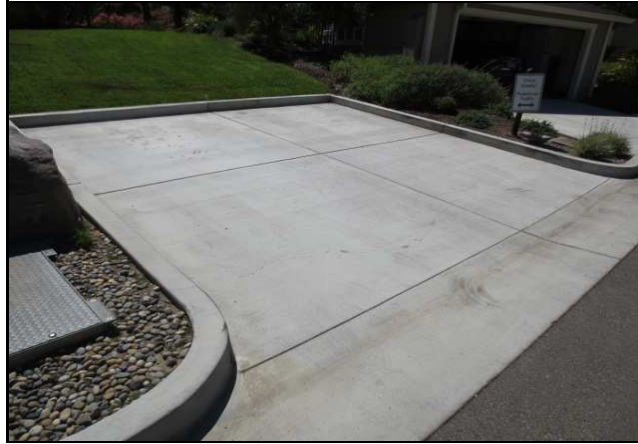
Comp # : 103 Concrete Surfaces - Repair

Evaluation : Well maintained and clean. No excessive lifting or cracking observed. Fair condition overall. Monitor for trip hazards and any signs of advanced deterioration. Handle minor repairs as an Operating expense.

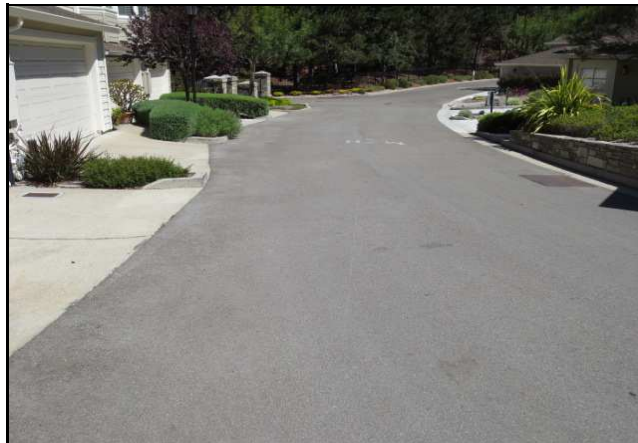
Evaluation : The road is well sloped to shed water. No Signs of major cracks or abnormal deterioration. Seal every 4-5 years to protect the integrity of the asphalt and maximize its useful life.

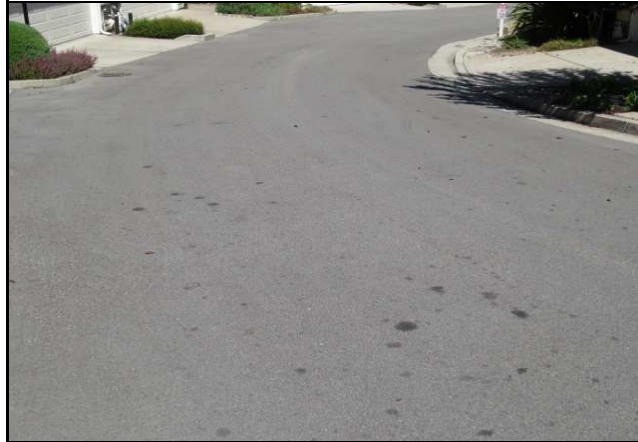
Comp # : 202 Asphalt - Seal/Repair

Evaluation : Minor granule exposure and some light cracking observed. Monitor for any tree root impaction. Regular cycles of seal coating, along with any needed repairs, has proven to be the most cost effective program for the long-term care of asphalt. We recommend sealing and repairing the asphalt every 4-5 years.

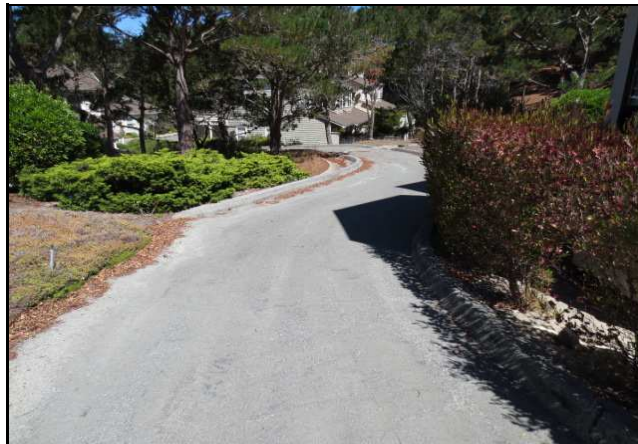
Comp # : 203 Asphalt Path - Resurface/Repair

Evaluation : The asphalt path that connects to the neighboring Association is in poor condition. While major surface wear and loss of seal is apparent, the path does not require the same maintenance as the road. Funding will need to be adjusted when major replacement becomes necessary. Handle repairs as an operating expense when needed. Reserve funding not allocated at this time.

Funded? : No . Handle repairs as an Operating expense as needed. No Reserve funding allocated.

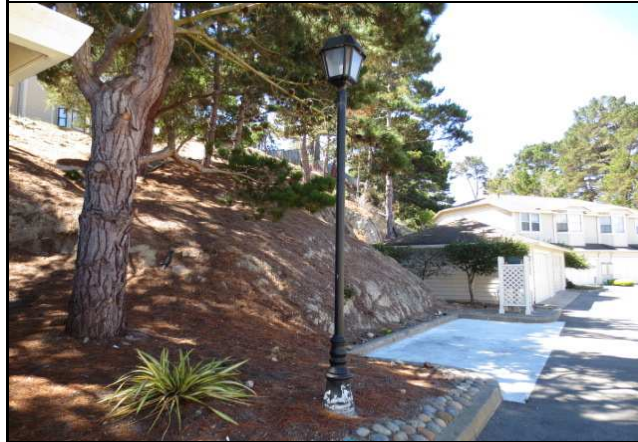
Comp # : 320 Pole Lights - Replace

Evaluation : Most fixtures are upright and have fair paint coverage. Isolated pole lights are leaning slightly and require some touchup paint. Continue to paint to maintain a positive appearance, we anticipate replacement in the interval outlined below.

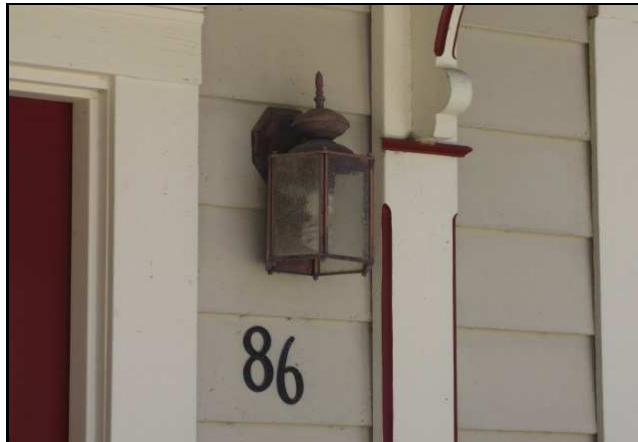
Comp # : 324 Wall Lights - Replace

Evaluation : Fixtures not tested during the site inspection; assume functional. Minor corrosion and dirt/dust accumulation noted. We recommend regular paint cycles and adjusting misaligned fixtures to maintain an attractive appearance. We anticipate replacement in the interval outlined below.

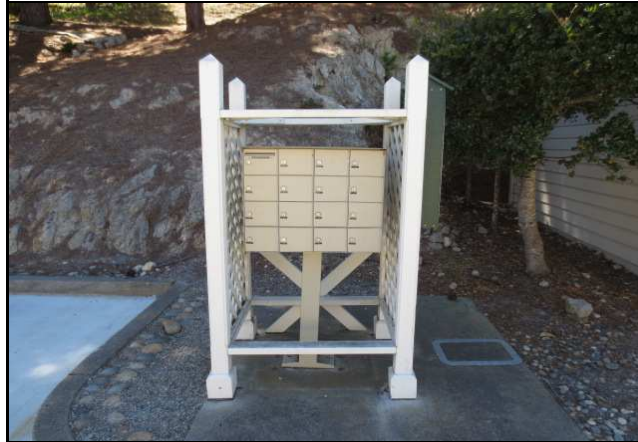
Comp # : 403 Mailboxes - Replace

Evaluation : Mailboxes are intact and upright. Minor surface wear observed, but no major damage. We recommend periodic cleaning and painting to protect against rust. This component provides funding for replacement in the interval outlined below.

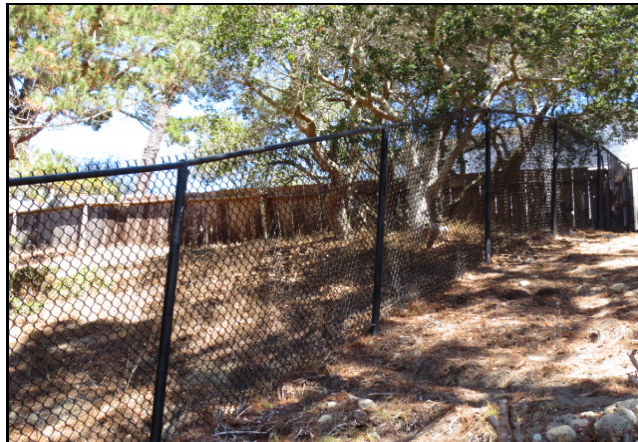
Comp # : 502 Chain Link Fence - Replace

Evaluation : The perimeter fencing conditions vary by location. Minor leaning in areas with uneven terrain and light discoloration in locations with greater solar exposure. This component provides funding to replace all chain link fencing as outlined below.

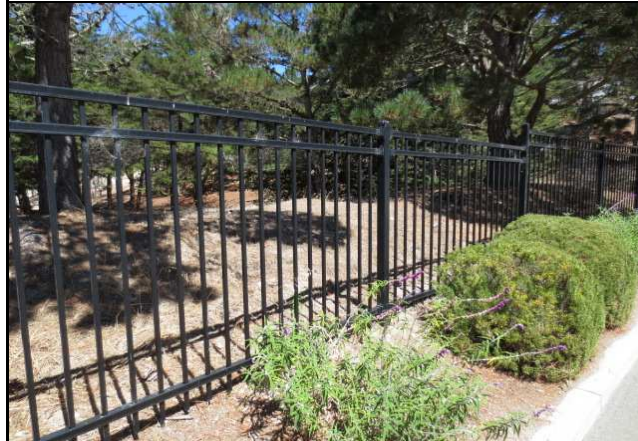
Comp # : 503 Metal Fence - Replace

Evaluation : No signs of advanced or abnormal deterioration. Upright and intact. We recommend periodic painting to prevent corrosion/oxidation. Complete replacement expected at the interval outlined below or as future conditions dictate.

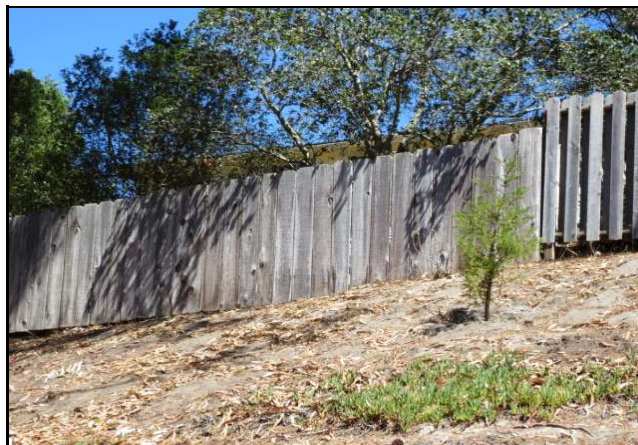
Comp # : 505 Wood Fence - Partial Replace

Evaluation : The wood fence is in fair condition overall, but minor deterioration noted. Missing boards and leaning observed in isolated locations. No expectation to replace all areas at one time. This component provides funding for partial replacement in the interval outlined below.

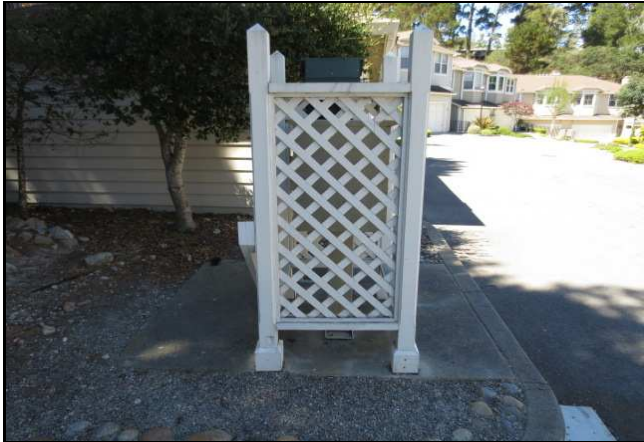
Comp # : 506 Lattice Fence - Repair

Evaluation : According to the Board, the Association is handling repairs as an operating expense.

Funded? : No . According to the Board, the Association is handling repairs as an Operating expense. No Reserve funding necessary at this time.

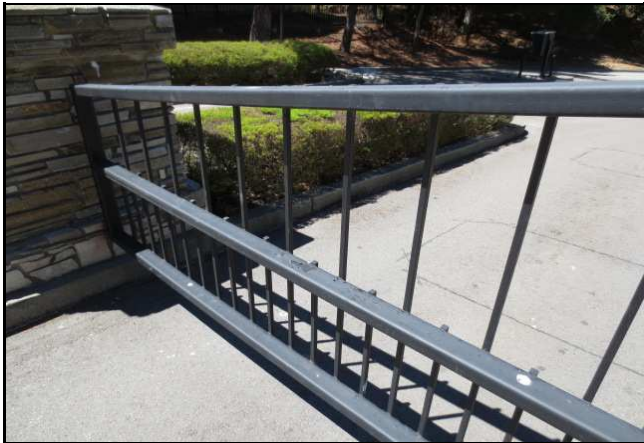
Comp # : 702 Vehicle Gates - Replace

Evaluation : The vehicle gates are functional and smooth operating. No abnormal damage or abuse noted. We recommend regular paint cycles to maintain an attractive appearance and protect metal from corrosion. Contact the servicing vendor if a pattern of deterioration develops. We anticipate replacement in the interval outlined below.

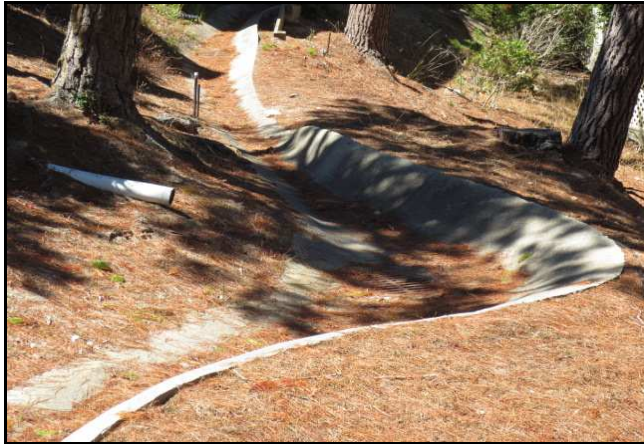
Comp # : 1703 Drainage - Repair		Quantity: Extensive LF
Location : Common area		
Funded? : No . According to the BOD, drainage has not been an issue and repairs are handled as Operating expenses when needed. Reserve funding not allocated at this time.		
History :		
Evaluation : Continue to monitor the common area drainage and adjust funding if repairs become too much for the Operating budget to absorb. Remove debris to ensure proper water drainage.		
Useful Life:
