## Update "With-Site-Visit" Reserve Study

### **The Glen of Pacific Grove Pacific Grove, CA**

**Report #: 7492-6**  
**For Period Beginning: January 1, 2019**  
**Expires: December 31, 2019**

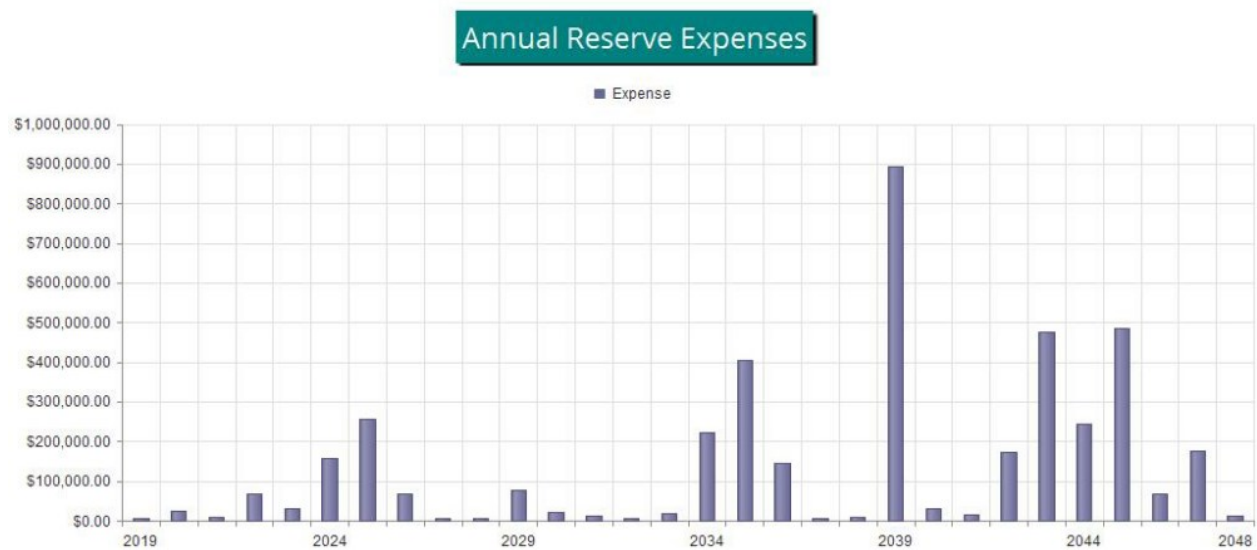
Figure 1

The figure below summarizes the projected future expenses at your property as defined by your Reserve Component List. A summary of these components are shown in the Component Details table, while a summary of the expenses themselves are shown in the 30-yr Expense Summary table.

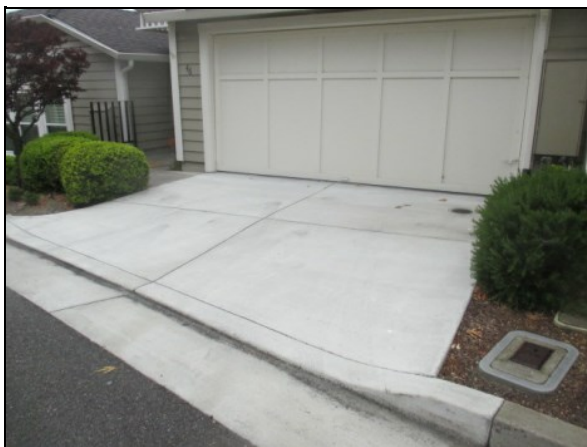
### Comp #: 103 Concrete Surfaces - Repair

History: 2017 - Repairs of \$5200 for cement work involving 2 driveways that needed to be re-done because of leaking main drains. 2018 - Repairs of \$3,100.

Useful Life:  
10 years

Remaining Life:  
5 years

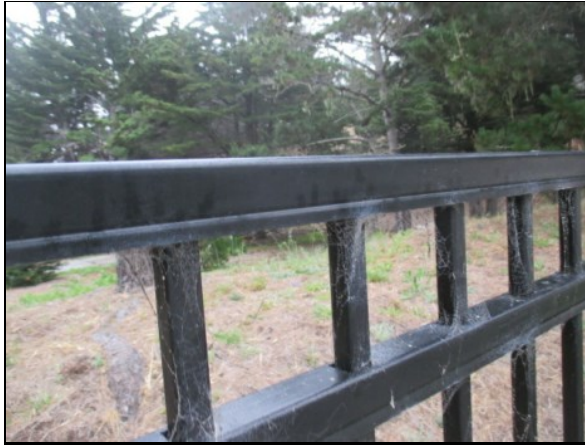
Evaluation: Due to high levels of solar exposure, minor fading of the paint has occurred. We recommend painting metal fencing every 4-5 years to protect against corrosion and other factors that accelerate deterioration.

Useful Life:  
5 yearsRemaining Life:  
3 years

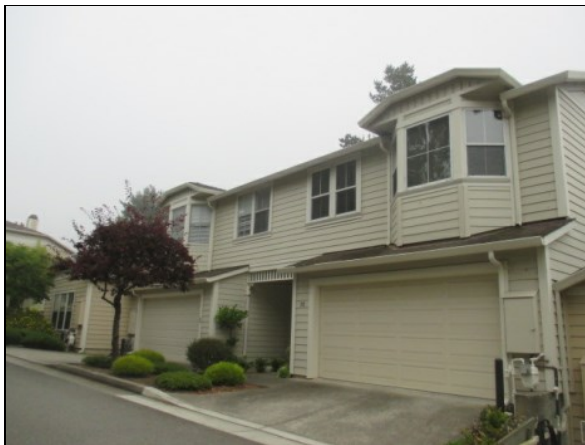
Evaluation: We recommend consistent paint cycles to the Hardie board siding and wood surfaces to protect from water intrusion and other factors that contribute to deterioration. The useful life of this component was provided by the BOD. Adjust the timing of the next painting project as needed. The surfaces may require painting more frequently in the future.

Useful Life:  
10 yearsRemaining Life:  
6 years
